# *Reliable Home Inspections*

## Property Inspection Report

123 Easy St, Graceland, TX 70000  
Inspection prepared for: New Buyer  
Real Estate Agent: -

Date of Inspection: 1/20/2016 Time: 1:00 PM  
Age of Home: 1992 Size: 2294  
Weather: Clear  
Order ID: 1279

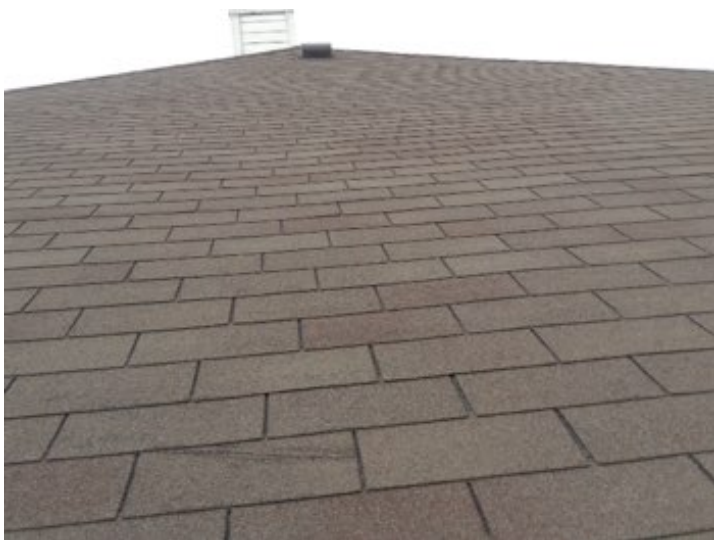
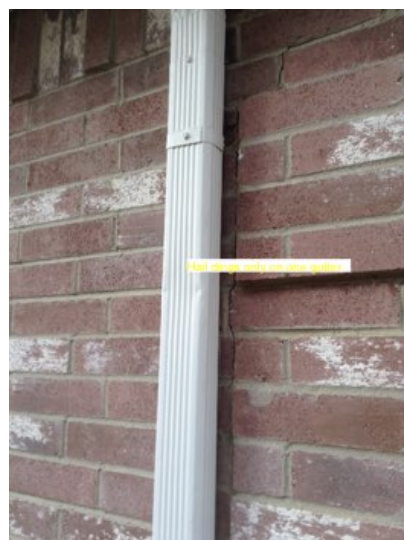
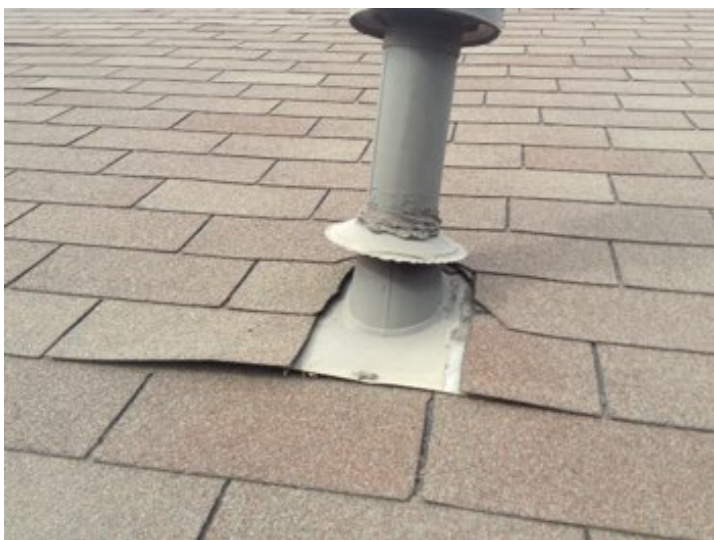
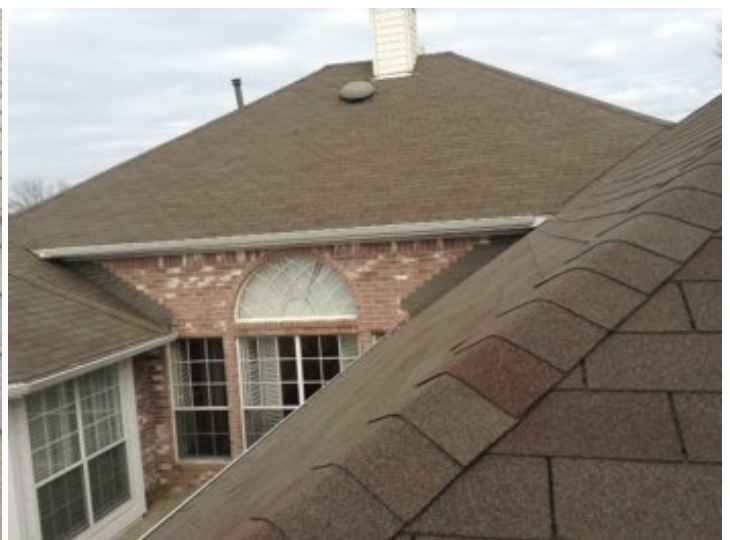
Minor repairs to the roofing are recommended. Damaged or missing roofing material should be repaired. All roof penetrations should be examined and sealed as necessary by a qualified roofing contractor.

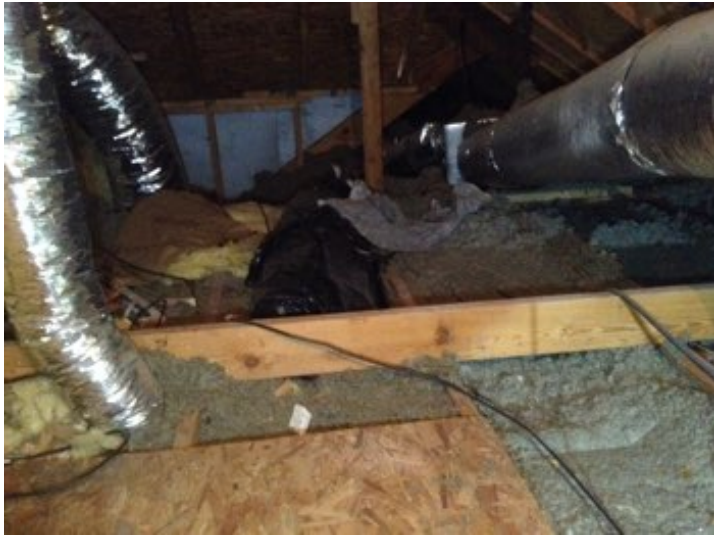
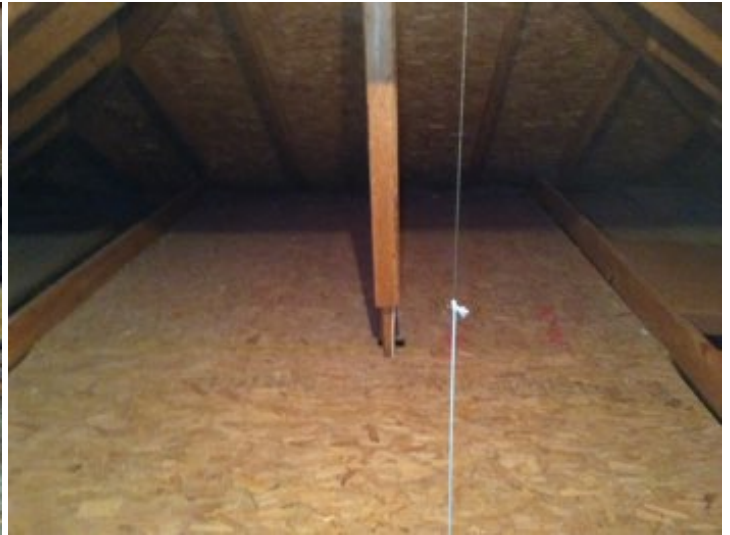
Approximate Average Depth of Insulation: Attic floor insulation is 3 to 5 inches deep

Insulation improvements are needed. The suggested depth of insulation on an attic floor is 10 to 12 inches of loose fill or an R-Factor of R-38 or more.

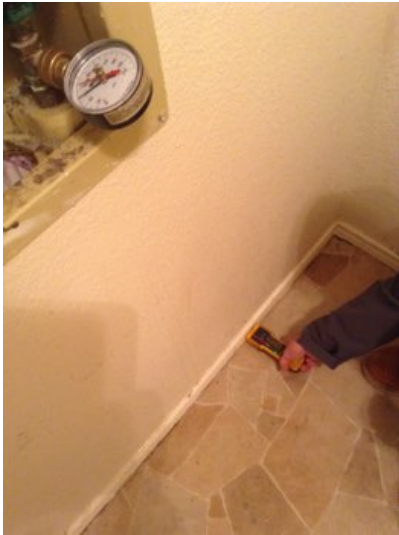
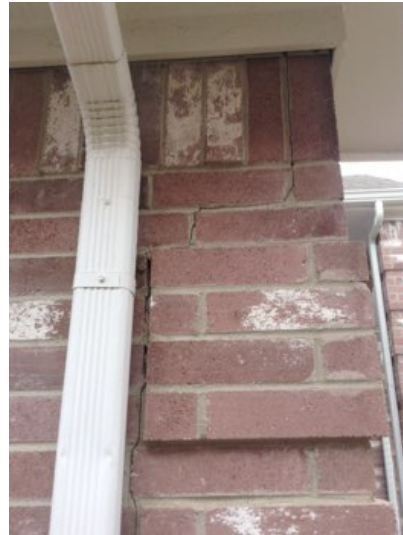
E.2. The laundry room wall and baseboard need to be repaired due to moisture damage.

The laundry room wall and baseboard need to be repaired due to moisture damage.

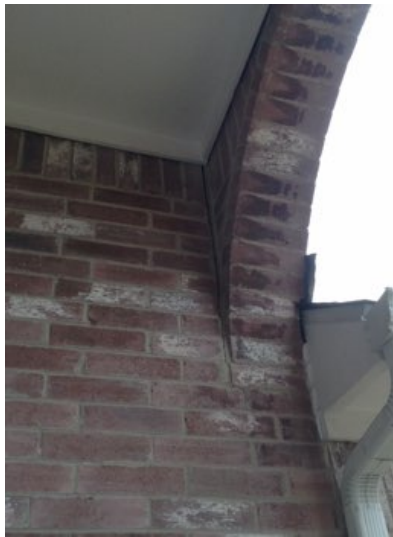
E.3. Slightly larger than typical exterior wall cracking was observed. The amount of movement does not suggest a serious structural problem. This area should, of course, be monitored. The rate of movement cannot be predicted during a one-time inspection. Front entry and right corner facing out the front door.

Slightly larger than typical exterior wall cracking was observed. The amount of movement does not suggest a serious structural problem. This area should, of course, be monitored. The rate of movement cannot be predicted during a one-time inspection. Front entry and right corner facing out the front door.

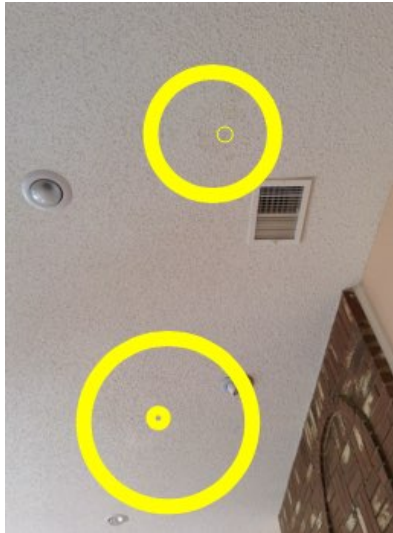
F.1. Water staining was noted in the middle bedroom closet and living room. The cause for the staining could not be determined and no moisture is present. Cosmetic repairs needed.

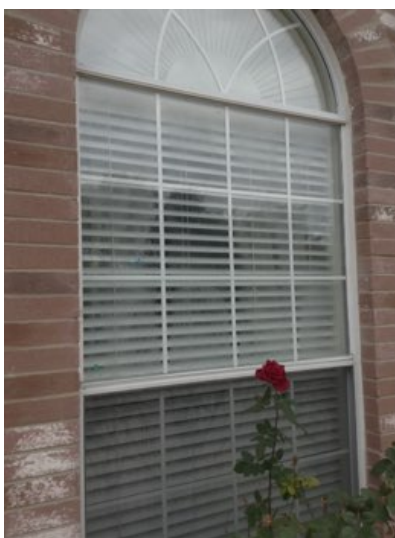
H.2. The window(s) have lost their seal. This has resulted in condensation developing between the panes of glass and can cause the glass to lose its insulating properties. The glass should be repaired or replaced.  
 All windows are marked by previous inspector (greater than eight)

The window(s) have lost their seal. This has resulted in condensation developing between the panes of glass and can cause the glass to lose its insulating properties. The glass should be repaired or replaced.  
 All windows are marked by previous inspector (greater than eight)

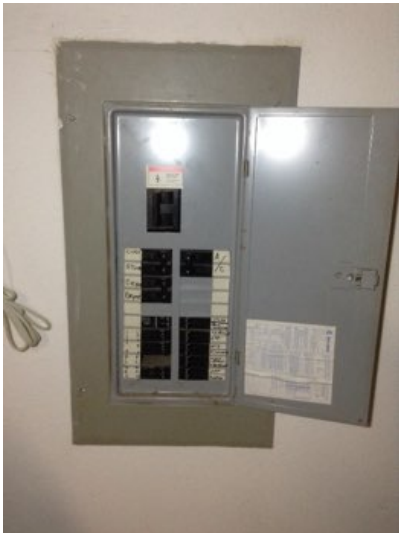
Any openings in the main panel should be covered. Clips can be added to avoid vermin entry points and danger of hands entering the open area.

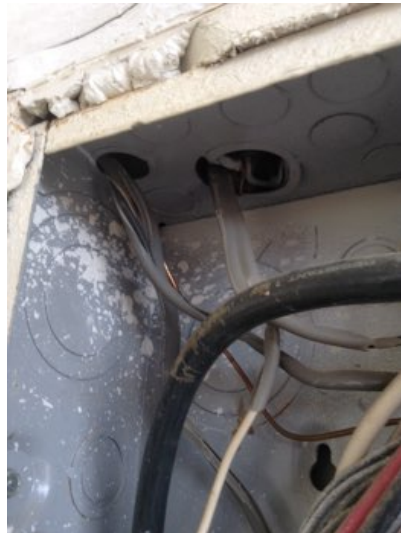
A.3. Cable clamps (sometimes referred to as bushings or grommets) are required where wiring passes into the main distribution panel. Cable clamps serve to protect the wiring from the metal edges of the panel openings.

Cable clamps (sometimes referred to as bushings or grommets) are required where wiring passes into the main distribution panel. Cable clamps serve to protect the wiring from the metal edges of the panel openings.

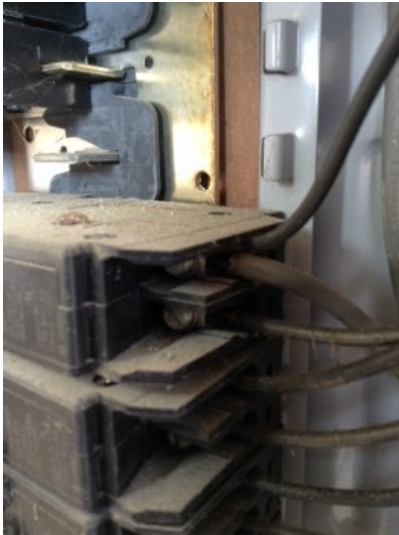
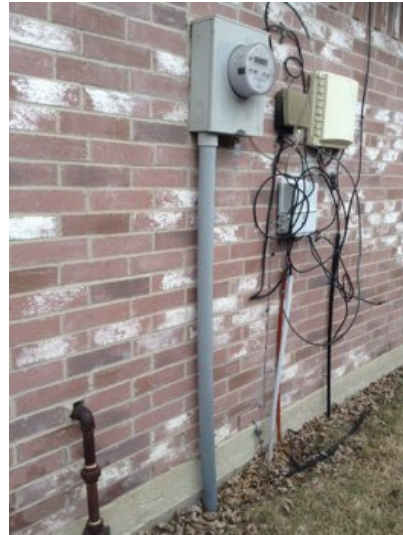
Circuits within the main distribution panel that are doubled up (referred to as "double taps") should be separated. Each circuit should be served by a separate fuse or breaker. This needs to be corrected by a licensed electrician.

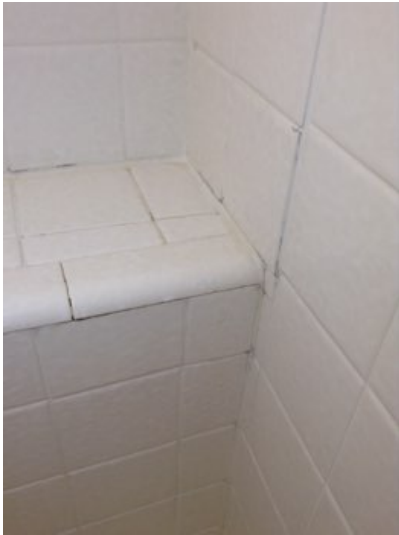
A.6. The tile shower stall requires repair. Loose or damaged tile, grout and caulk should be repaired or replaced as necessary. Any damage to the wall behind the tile should also be repaired (if necessary). Further investigation may reveal the need to rebuild a portion of the shower stall.

The tile shower stall requires repair. Loose or damaged tile, grout and caulk should be repaired or replaced as necessary. Any damage to the wall behind the tile should also be repaired (if necessary). Further investigation may reveal the need to rebuild a portion of the shower stall.

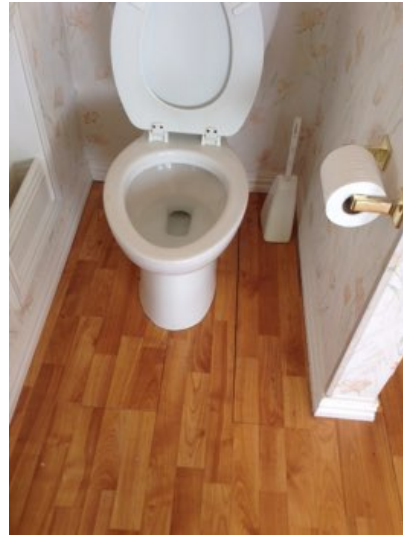
A.4. The toilet shows evidence of prior leakage at the base. This should be repaired to avoid any more flooring damage. Damaged flooring should be replaced.

The toilet shows evidence of prior leakage at the base. This should be repaired to avoid any more flooring damage. Damaged flooring should be replaced.

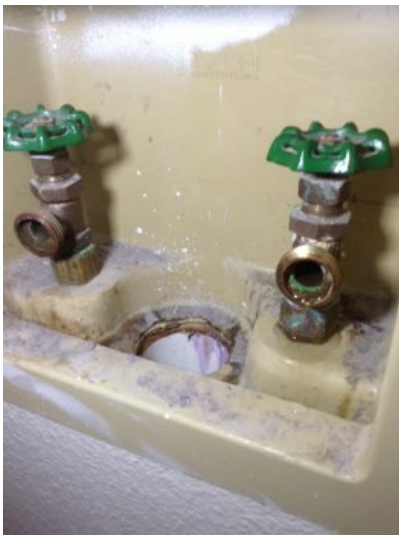
A.8. The hose bibs at the laundry connections are leaking and should be repaired. The baseboard wood is wet when measured with a moisture meter. The wall will need to be remediated for moisture damage.

The hose bibs at the laundry connections are leaking and should be repaired. The baseboard wood is wet when measured with a moisture meter. The wall will need to be remediated for moisture damage.

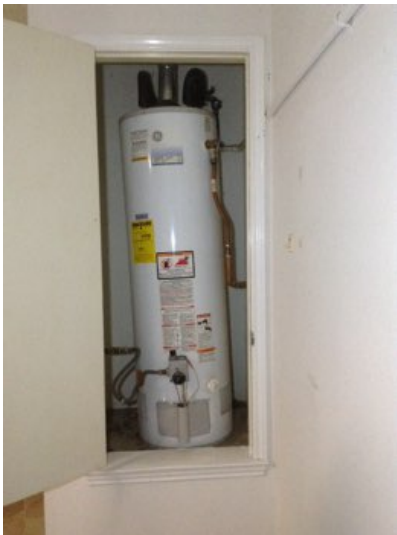
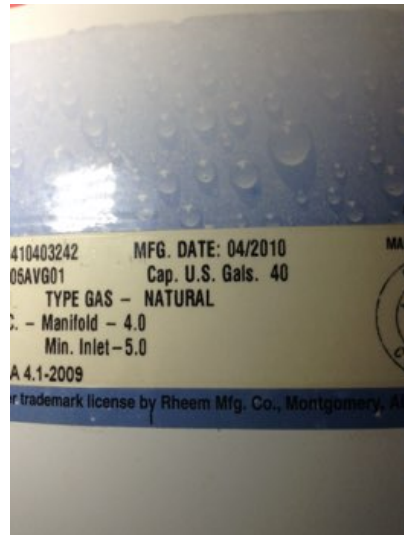
C.2. No safety pan and drain was found for the water heater. This should be repaired by the installation of a pan with a drain by a qualified contractor.

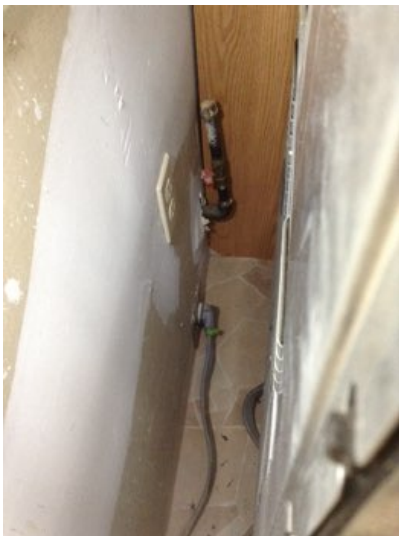
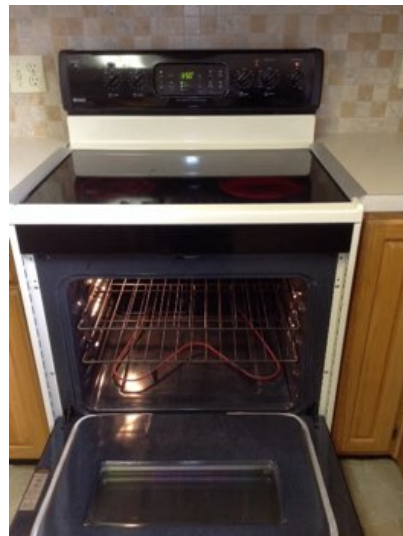
D.2. The range requires an anti tip device to be installed for child safety. The ranges comes with the device when sold and is required for safety concerns.

The range requires an anti tip device to be installed for child safety. The ranges comes with the device when sold and is required for safety concerns.

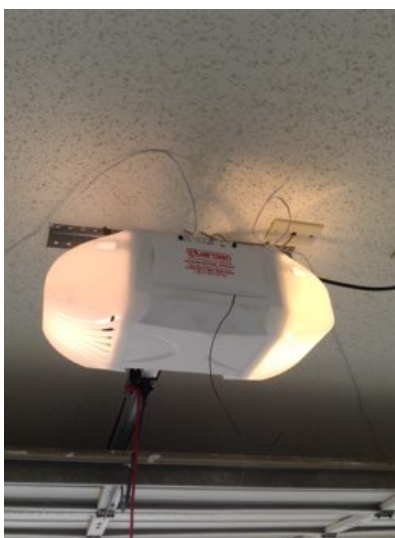
G.1. The garage door opener did not automatically reverse under resistance to closing. There is a serious risk of injury, particularly to children, under this condition. Improvement may be as simple as adjusting the sensitivity control on the opener. This should be repaired immediately.

The garage door opener did not automatically reverse under resistance to closing. There is a serious risk of injury, particularly to children, under this condition. Improvement may be as simple as adjusting the sensitivity control on the opener. This should be repaired immediately.

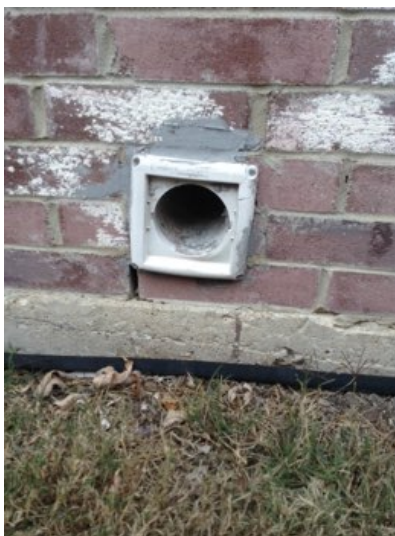
H.1. The dryer vent exterior cover is missing

The dryer vent exterior cover is missing

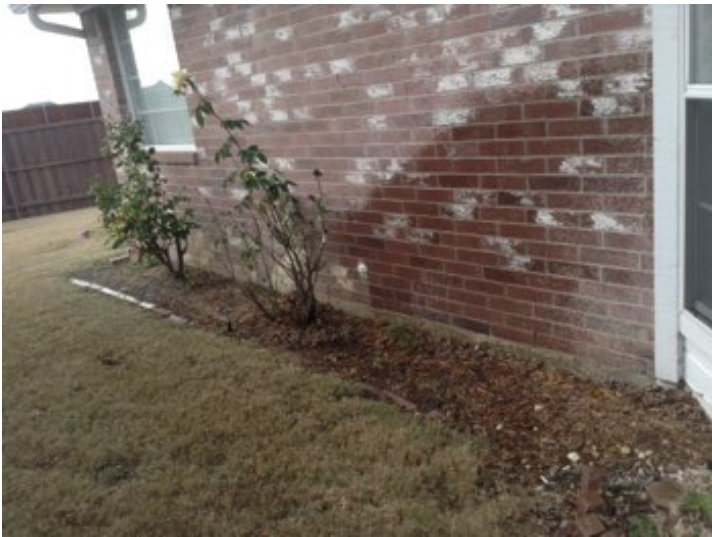
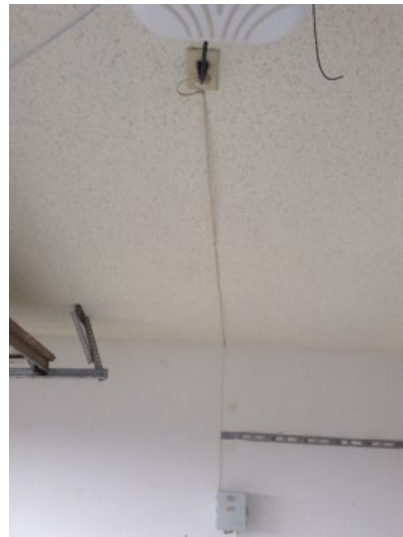
A.1. The wiring for the sprinkler system control box is improper and should be repaired. The unit is wired with an extension cord.

The wiring for the sprinkler system control box is improper and should be repaired. The unit is wired with an extension cord.

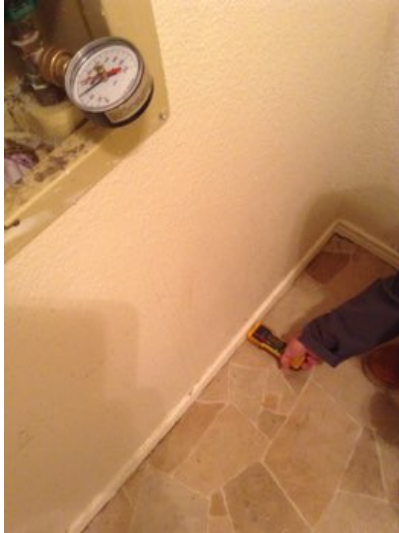
The laundry room wall and baseboard need to be repaired due to moisture damage.

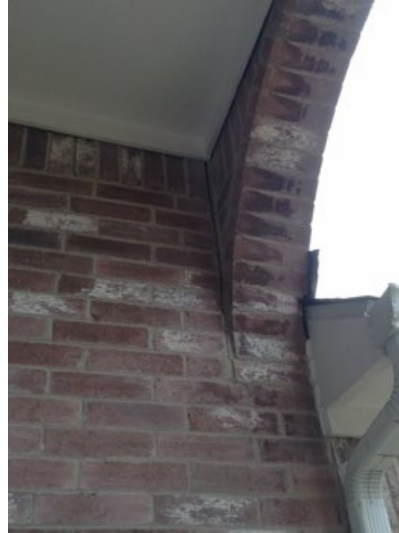
Slightly larger than typical exterior wall cracking was observed. The amount of movement does not suggest a serious structural problem. This area should, of course, be monitored. The rate of movement cannot be predicted during a one-time inspection. Front entry and right corner facing out the front door.

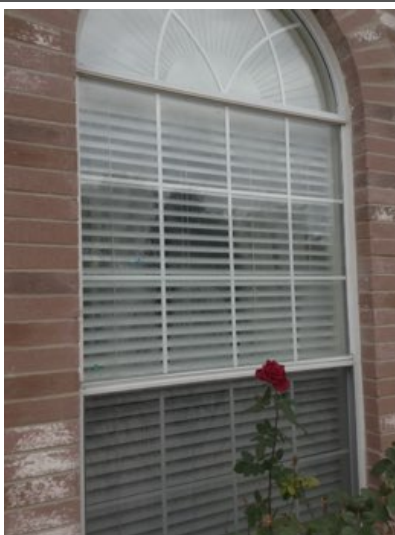
The window(s) have lost their seal. This has resulted in condensation developing between the panes of glass and can cause the glass to lose its insulating properties. The glass should be repaired or replaced.  
 All windows are marked by previous inspector (greater than eight)

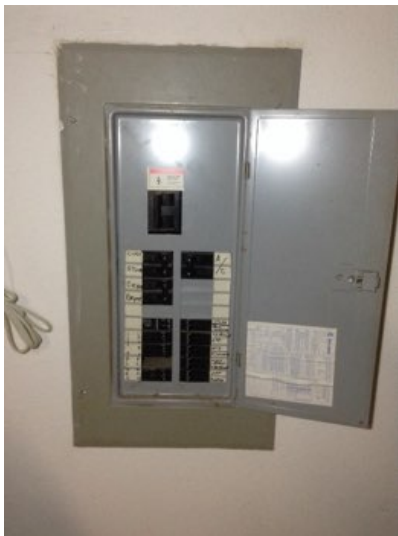
Any openings in the main panel should be covered. Clips can be added to avoid vermin entry points and danger of hands entering the open area.

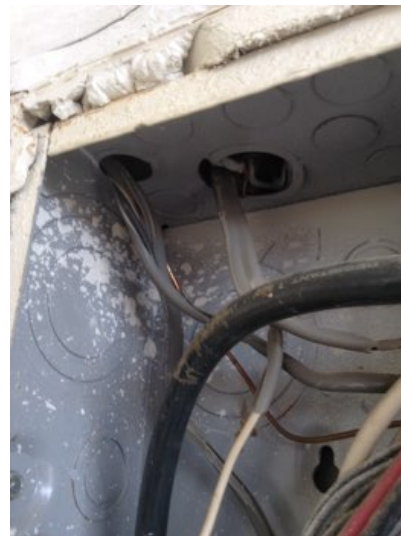
Cable clamps (sometimes referred to as bushings or grommets) are required where wiring passes into the main distribution panel. Cable clamps serve to protect the wiring from the metal edges of the panel openings.

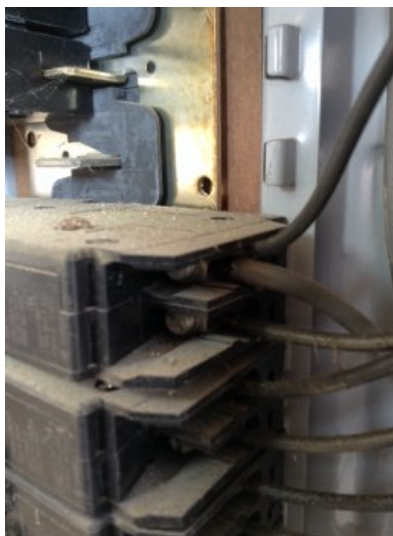
Circuits within the main distribution panel that are doubled up (referred to as "double taps") should be separated. Each circuit should be served by a separate fuse or breaker. This needs to be corrected by a licensed electrician.

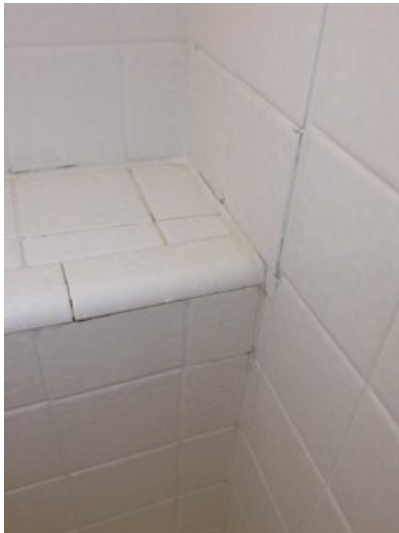
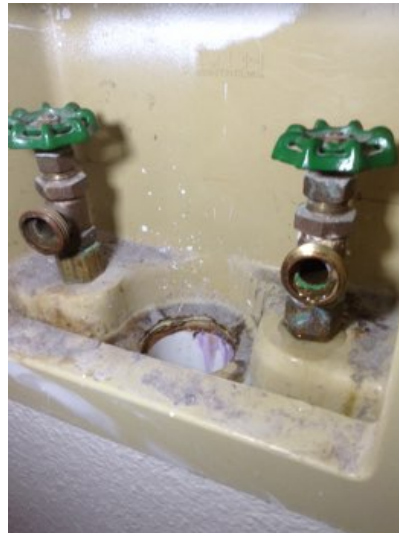
The tile shower stall requires repair. Loose or damaged tile, grout and caulk should be repaired or replaced as necessary. Any damage to the wall behind the tile should also be repaired (if necessary). Further investigation may reveal the need to rebuild a portion of the shower stall.

The hose bibs at the laundry connections are leaking and should be repaired. The baseboard wood is wet when measured with a moisture meter. The wall will need to be remediated for moisture damage.

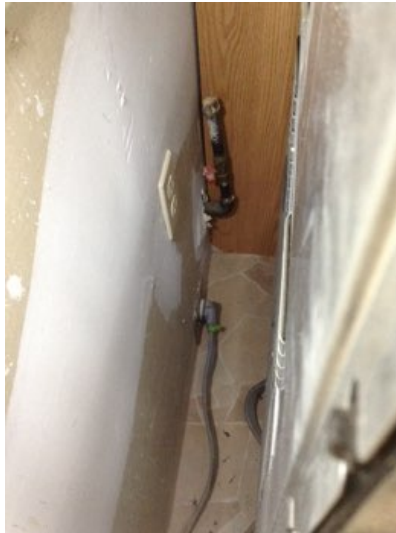
The range requires an anti tip device to be installed for child safety. The ranges comes with the device when sold and is required for safety concerns.

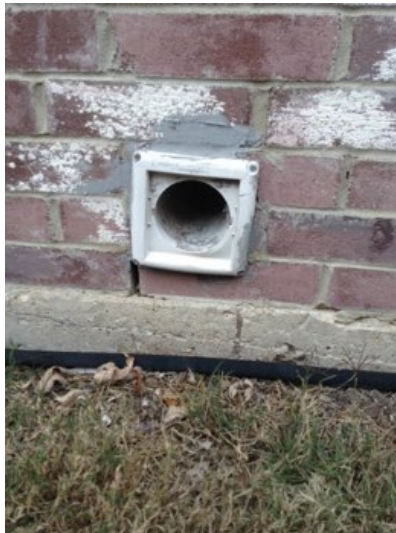
The dryer vent exterior cover is missing
