# *Reliable Home Inspections*

## Property Inspection Report

123 Easy St, Graceland, TX 70000  
Inspection prepared for: New Buyer  
Real Estate Agent: -

Date of Inspection: 1/20/2016 Time: 1:00 PM  
Age of Home: 1992 Size: 2294  
Weather: Clear  
Order ID: 1279

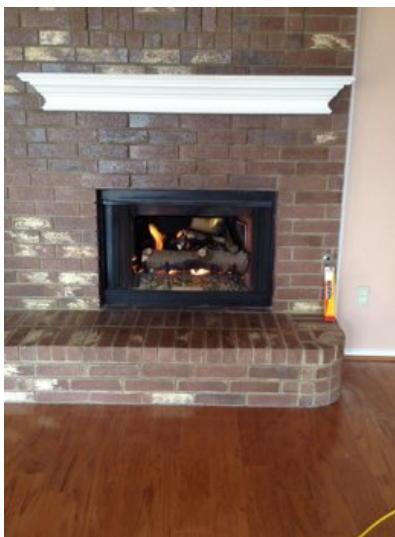
<input checked="" type="checkbox"/>	<input type="checkbox"/>	<input type="checkbox"/>	<input type="checkbox"/>	J. Fireplace/Chimney
-------------------------------------	--------------------------	--------------------------	--------------------------	----------------------

Locations: Fireplace is located in the living room  
 Types: Fireplace is prefabricated with gas logs installed.

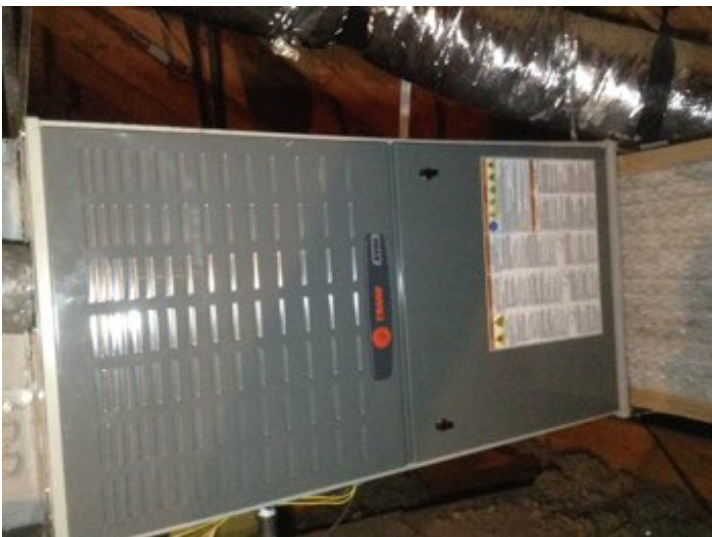
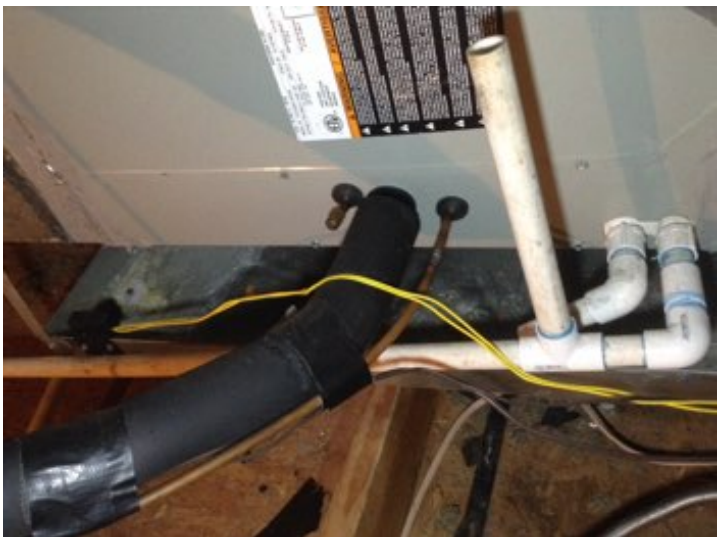
A.2. The air handler is located in the attic.

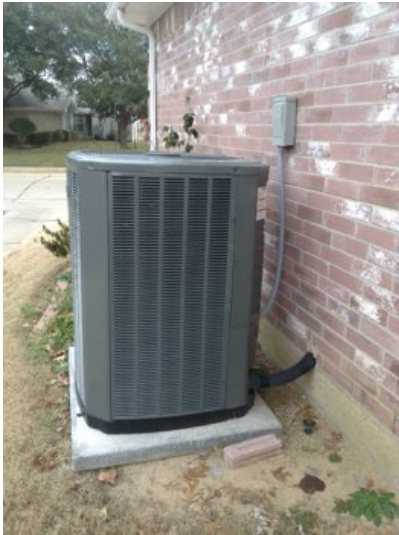
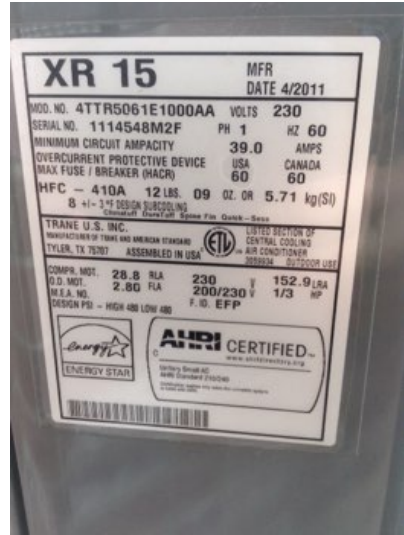
Central air split unit

15 Seer 4 ton MFD 2011

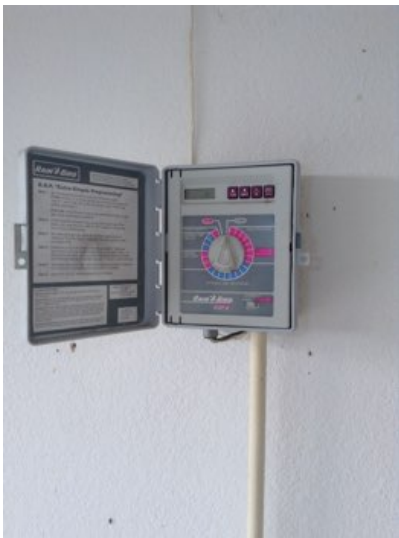
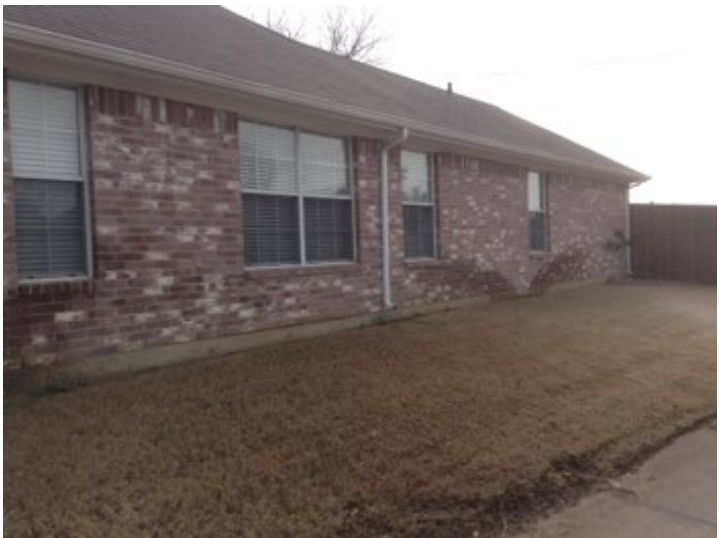
A.2. A rain sensor is required for the lawn sprinkler system and is considered standard equipment to avoid water waste. This is required by TREC rules and most municipalities.

A.3. The water spray from the sprinkler system should be re-directed away from the structure and/or any fencing, decks, etc., to decrease the possibility of damage.
